# Manhole Inspection Summary

Manhole # S13KK\_015MH

Insp Date: **9/6/07 3:30 PM**

**Location** Address: **WALBROOK AVE**

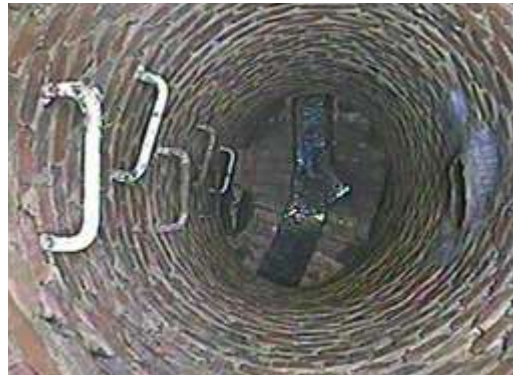
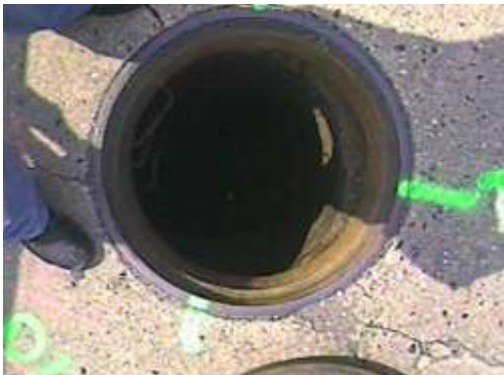
Top View

Condition: ☐ Sound ☐ Cracked ☐ Root Intrusion ☐ Deteriorated ☐ Leaks ☒ **Debris**

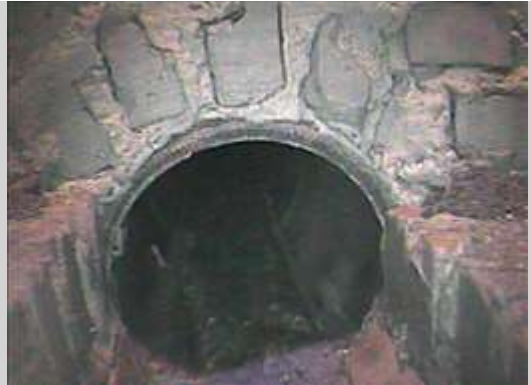
12 O'Clock Outflow

10 in. Circular Gravity Sewer  
Pipe Out @ 12 O'Clock

Pipe Height: (in.) Direct  
Pipe Material: **Clay** ☐ Pipe Lined  
Invert Depth: **14.76** (ft.) Flow Characteristics: **Slow**  
Deposits: ☒ None ☐ Mud ☐ Sludge ☐ Debris ☐ Grease  
Silt Depth: (in.) Deposits Extent:  
Infiltration: **None** Pipe Seal Cond: **Sound**

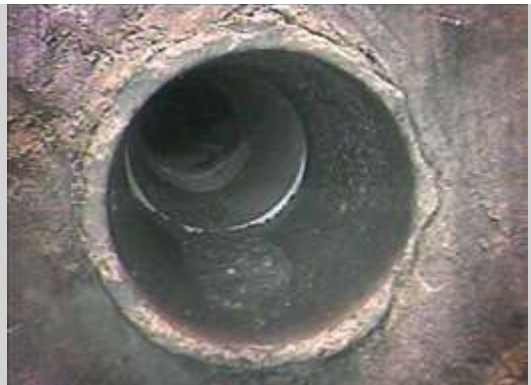
3 O'Clock Inflow

10 in. Circular Gravity Sewer  
Pipe In @ 3 O'Clock

Drop In @ 3 O'Clock

Pipe Height: (in.) Direct  
Pipe Material: **Clay** ☐ Pipe Lined  
Invert Depth: **8.52** (ft.) Flow Characteristics: **None**  
Deposits: ☒ None ☐ Mud ☐ Sludge ☐ Debris ☐ Grease  
Silt Depth: (in.) Deposits Extent:  
Infiltration: **None** Pipe Seal Cond: **Broken**

Drop: **Outside Direct**  
Angled: Reading: (ft.)  
Inv Depth: **14.17** (ft.)  
Drop Condition: **Clogged**

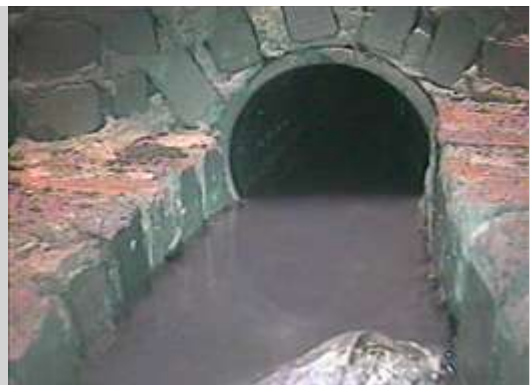
6 O'Clock Inflow

10 in. Circular Gravity Sewer  
Pipe In @ 6 O'Clock

Invert Depth: **14.41** (ft.) Flow Characteristics: **Slow**

Infiltration: **None** Pipe Seal Cond: **Sound**
